## DAIWA CS201

Genere	DATA	Generalità	Note	Distribuzione
radio	Jun 2014	Repair of switch cs120		Af web

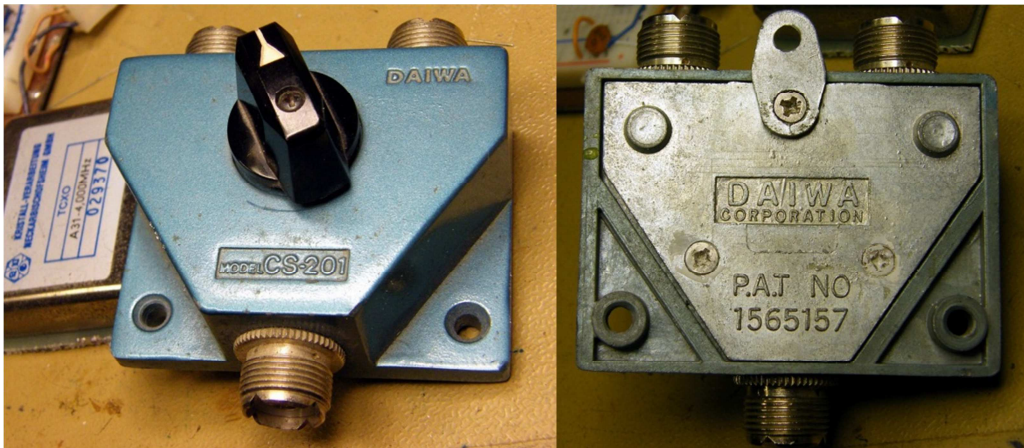
*This simple manual coaxial switch has been on duty a lot of time. Recently some problem has pop up. Mainly SWR.*

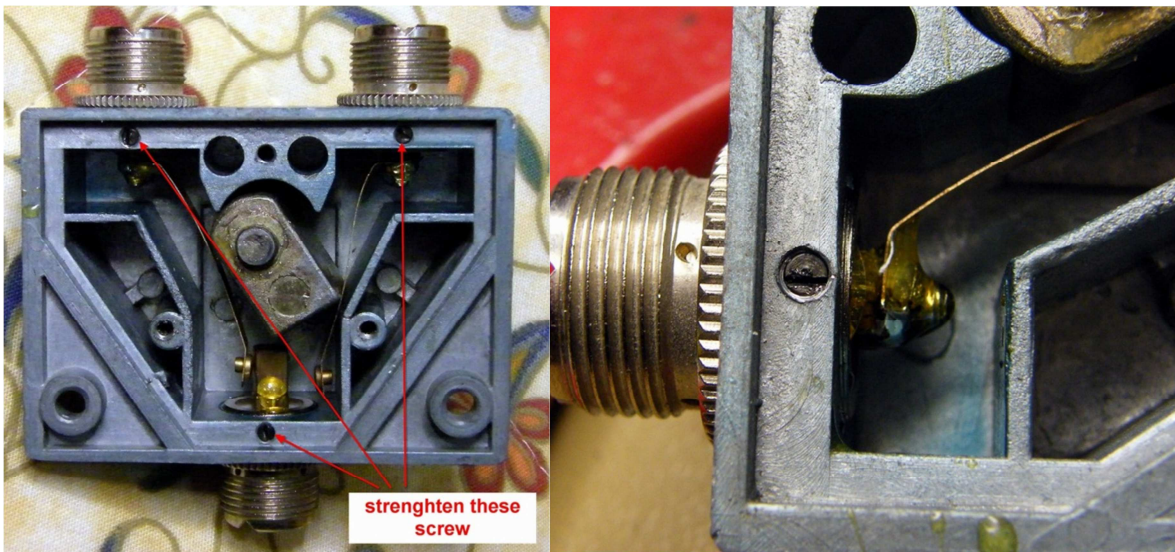
*So I've found all three SO239 coax socket loose in the main body of switch, with a little backlash. Solution was to tighten the grain as in the picture above. The screw quality is not the best, as the off side cut in the grain shows in the right picture, albeit sufficient to work.*
