## TELEFUNKEN CAPRICE 101 – OM FM RADIO RECEIVER

Genere	DATA	Generalità	Note	Distribuzione
Radio surplus	2012	TELEFUNKEN CAPRICE 101	S/N 200359

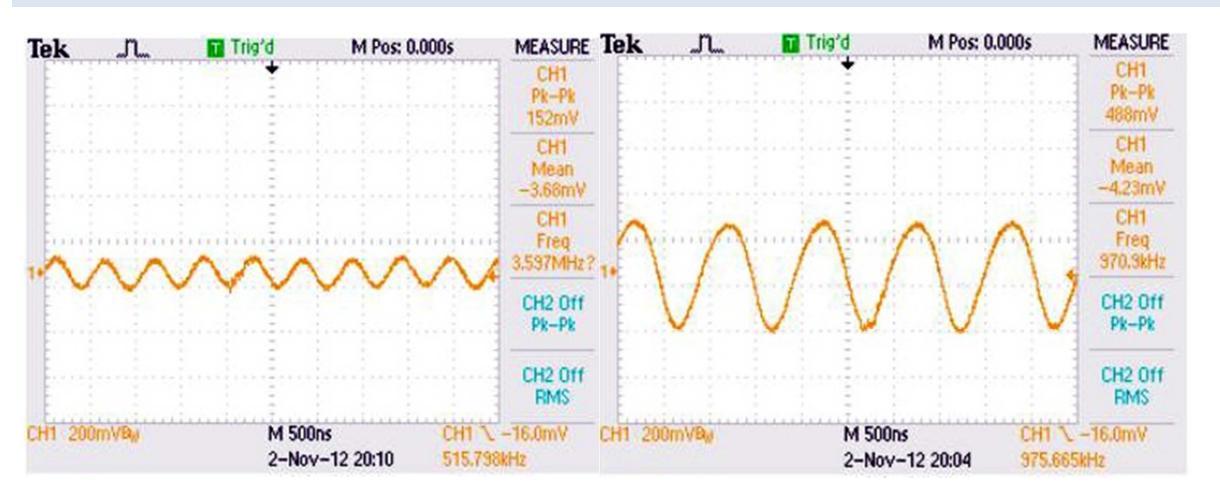
The pictures above show wave-shapes measured at Q3 collector (AM local oscillator and mixer – FM IF amplifier). Left waveform refers to AM2 band, righto to AM1.

The AM2 band sometimes does not work due to missing local oscillator. I've not understood the exact cause of this malfunction. And I observe that circuit realization is not as clean as it could be. Some wires are used instead of PCB connection. So I would try to separate the functions of mixer and oscillator, for medium wave bands by building a separate but identical oscillator coupled to mixer via emitters.

With only this modify the situation remains critical. Matter became simpler after adding a FET buffer. In this way also AM2 band has an oscillator with 1 Vpp voltage.

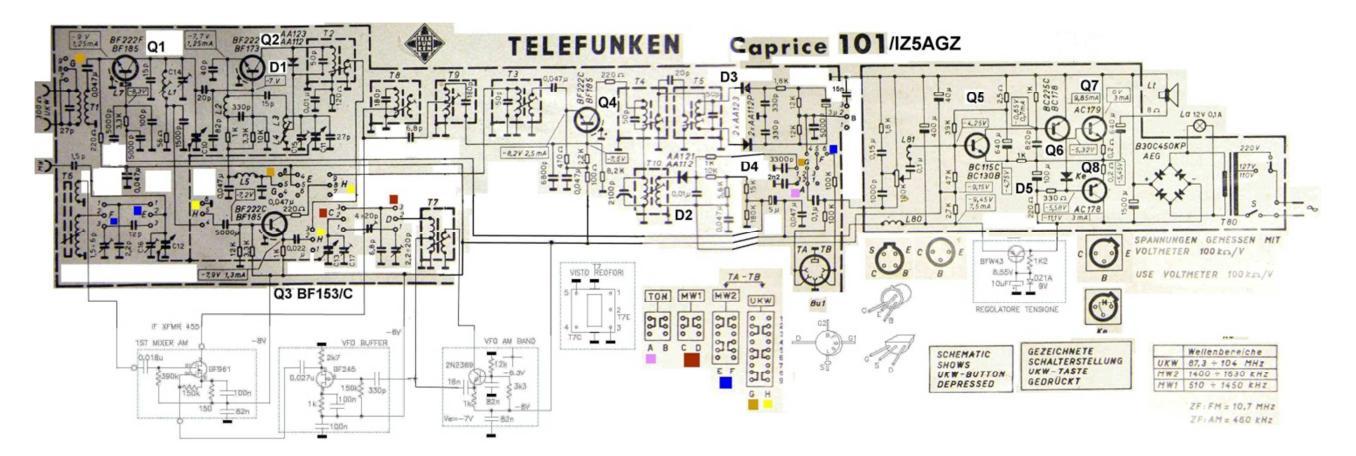
I executed another modify. This time to the mixer stage, now equipped with a dual gate MOSFET BF961 with input filter/ferrite antenna connected to gate 1 and not to the RF amplifier.

Operation of the receiver is now ok, without intermodulation. There are not strong medium wave tx in my area.

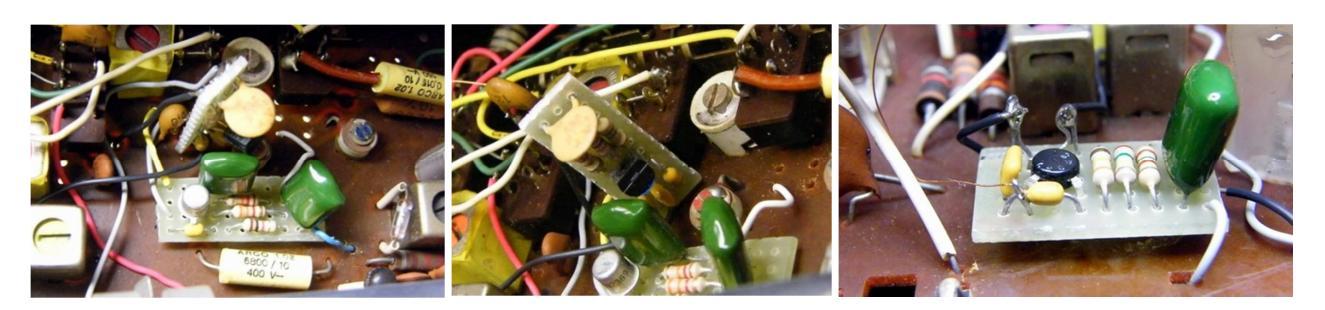
Pictures above show at left the new oscillator stage (AM VFO), center the buffer with BF245 and right the new mixer.

Each little module is built on a vetronite pre-drilled board, cut to suit components. module are completed with wires to connect ground, supply and signals. Connection wires also support mechanically the module.
